Seismic Retrofit of an Existing Multi-Story Wood Frame Structure

John M. Coil S. E.
Senior Vice President
Thornton-Tomasetti / Coil & Welsh *Engineers*.
Tustin, California

Abstract

This paper discusses the background and methodology associated with the seismic upgrading of a large multi-unit residential project. The advantages of using a rigid diaphragm analysis for the design and retrofit of this type of structure are demonstrated. The development of computer spread sheet analysis tool greatly aided in the design of the retrofit project.

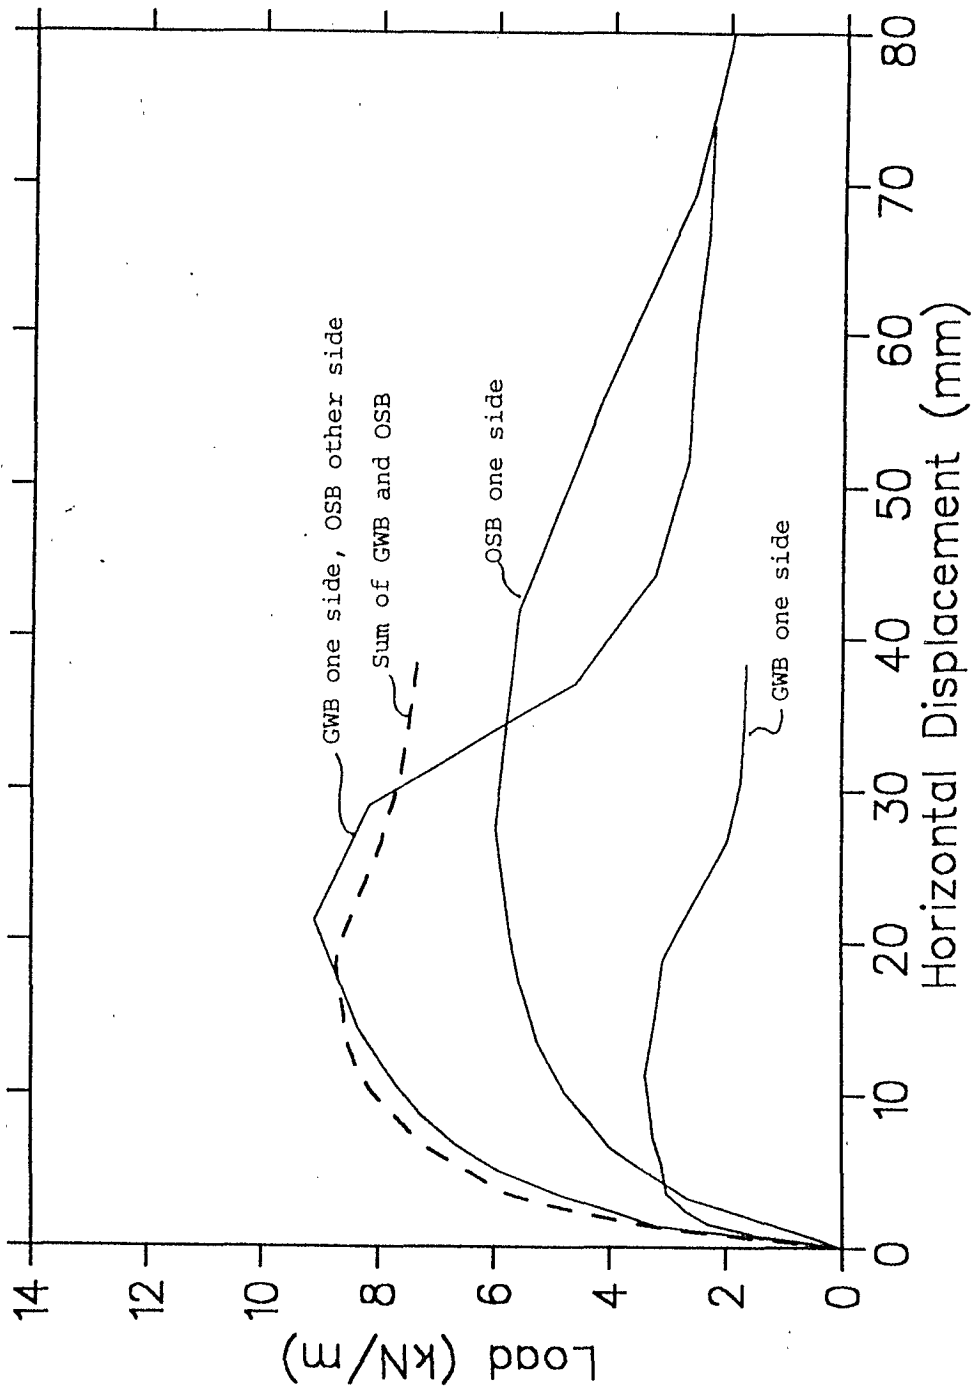
FIGURE 4

The plywood shear wall stiffness used in the analysis did not include the contribution of the gypsum board or the stucco. The code requirements do not allow such combination of materials for shear resistance, however, for modeling the stiffness of the other elements should be included. Dynamic load test conducted of walls with and without gypsum board show that the stiffness and strength may be additive, at least in the normal range of deformations. (See Fig 4) Additional research is needed in order to better model the shear walls with various material combinations for proper load distribution over the full range of performance.

Figure 6 Contribution of gypsum wall board to the stabilized load carrying capacity when used in combination with OSB
